approach

approach/july 1968

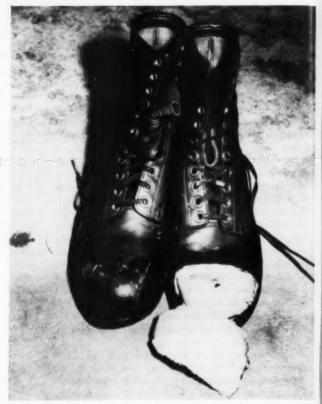
The steel tip of the left boot (above) was almost entirely cut off and the steel plate was knocked out when the wearer, an A-4B pilot, struck the cockpit during ejection. His feet were on the rudder pedals (as prescribed by NATOPS in a controlled ejection). His only injuries were very minor abrasions of his left foot and knee. His insignificant foot injury despite the condition of the flight boot is testimony to the protection it afforded, the investigating flight surgeon reports.

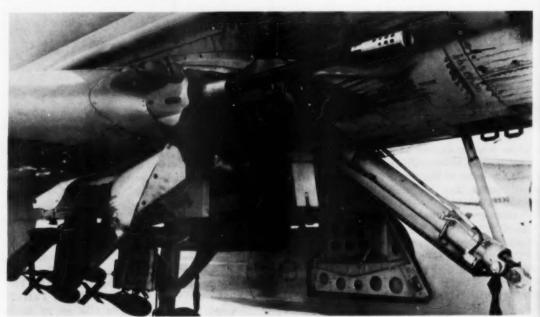
Improper maintenance can lead to undesired explosions.
